# Aztech Environmental

## **RE: Sub-Slab Depressurization System (SSDS) – 2017 Annual Inspection**

The three (3) SSDSs installed at 510 Furnace Dock Road (the site) located in Cortlandt Manor, New York have been operational since their installation in December of 2011. Each of the three (3) individual systems is comprised of two (2) sub-slab vapor extraction points. All three (3) systems are equipped with Radonaway HS-2000 fan units. Each system is also equipped with a pressure indicating alarm which illuminates a light in the event that the vacuum inside of the system falls below 0.25 inches of water column. All plumbing was completed using three-inch Schedule 40 PVC pipe and solvent-welded fittings. The three (3) fans were mounted securely to the roof and all piping was installed on a pitch to allow any condensation to flow back into the ground beneath the building's slab.

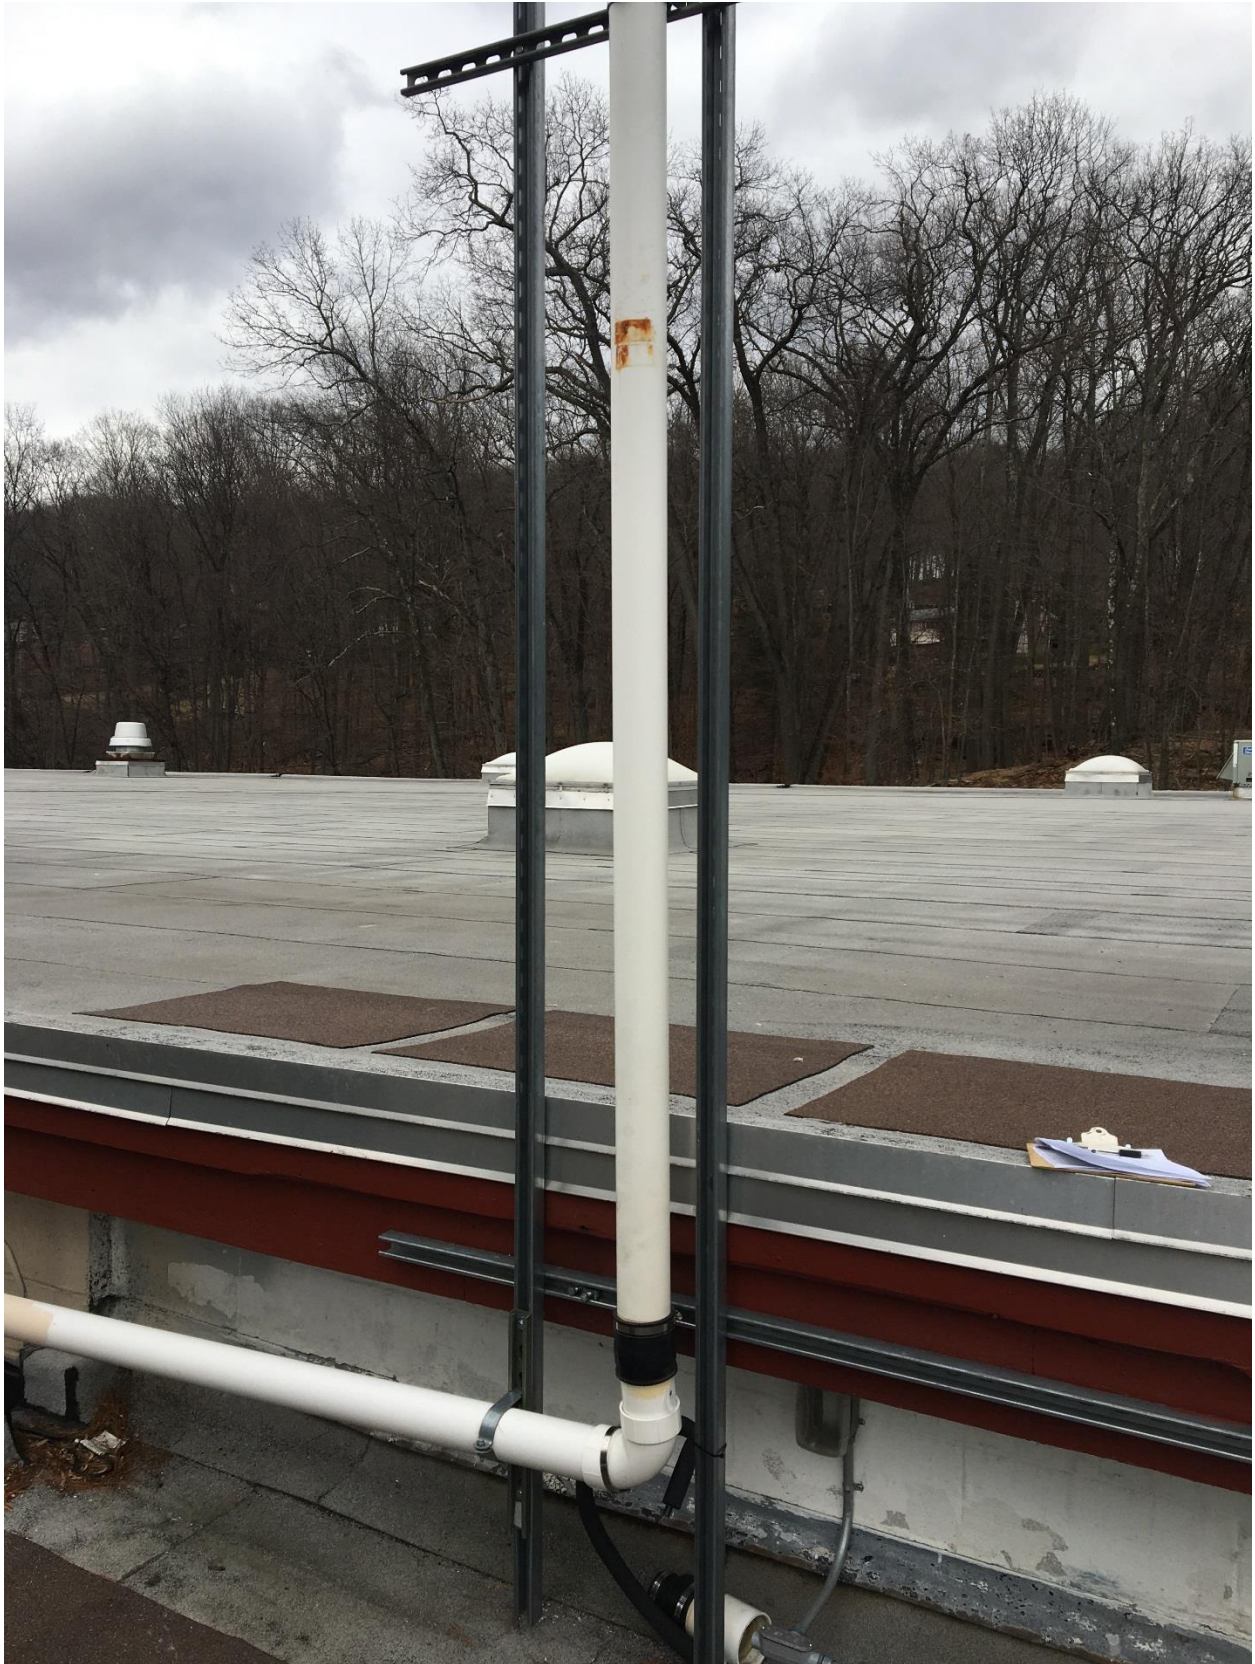
On January 27<sup>th</sup> 2017, Aztech personnel mobilized to the site to determine the cause of a vacuum alarm. Upon inspection, it was discovered that the Northern Fan was inoperable and causing the ground fault circuit interrupter (GFCI) to trip. The fan was removed during this visit until a

**Seen here is the Northern Fan with the malfunctioning fan removed. The piping was connected temporarily to allow for venting while a replacement was sourced.**

replacement could be sourced. The stack was temporarily installed directly to the piping in order to allow the system to passively vent safely in the absence of an induced vacuum. On February 15<sup>th</sup> 2017, Aztech personnel remobilized to the site to replace the Northern Fan with a new HS-2000 unit. Proper operation was proved and the vacuum alarm was no longer in a fault condition.

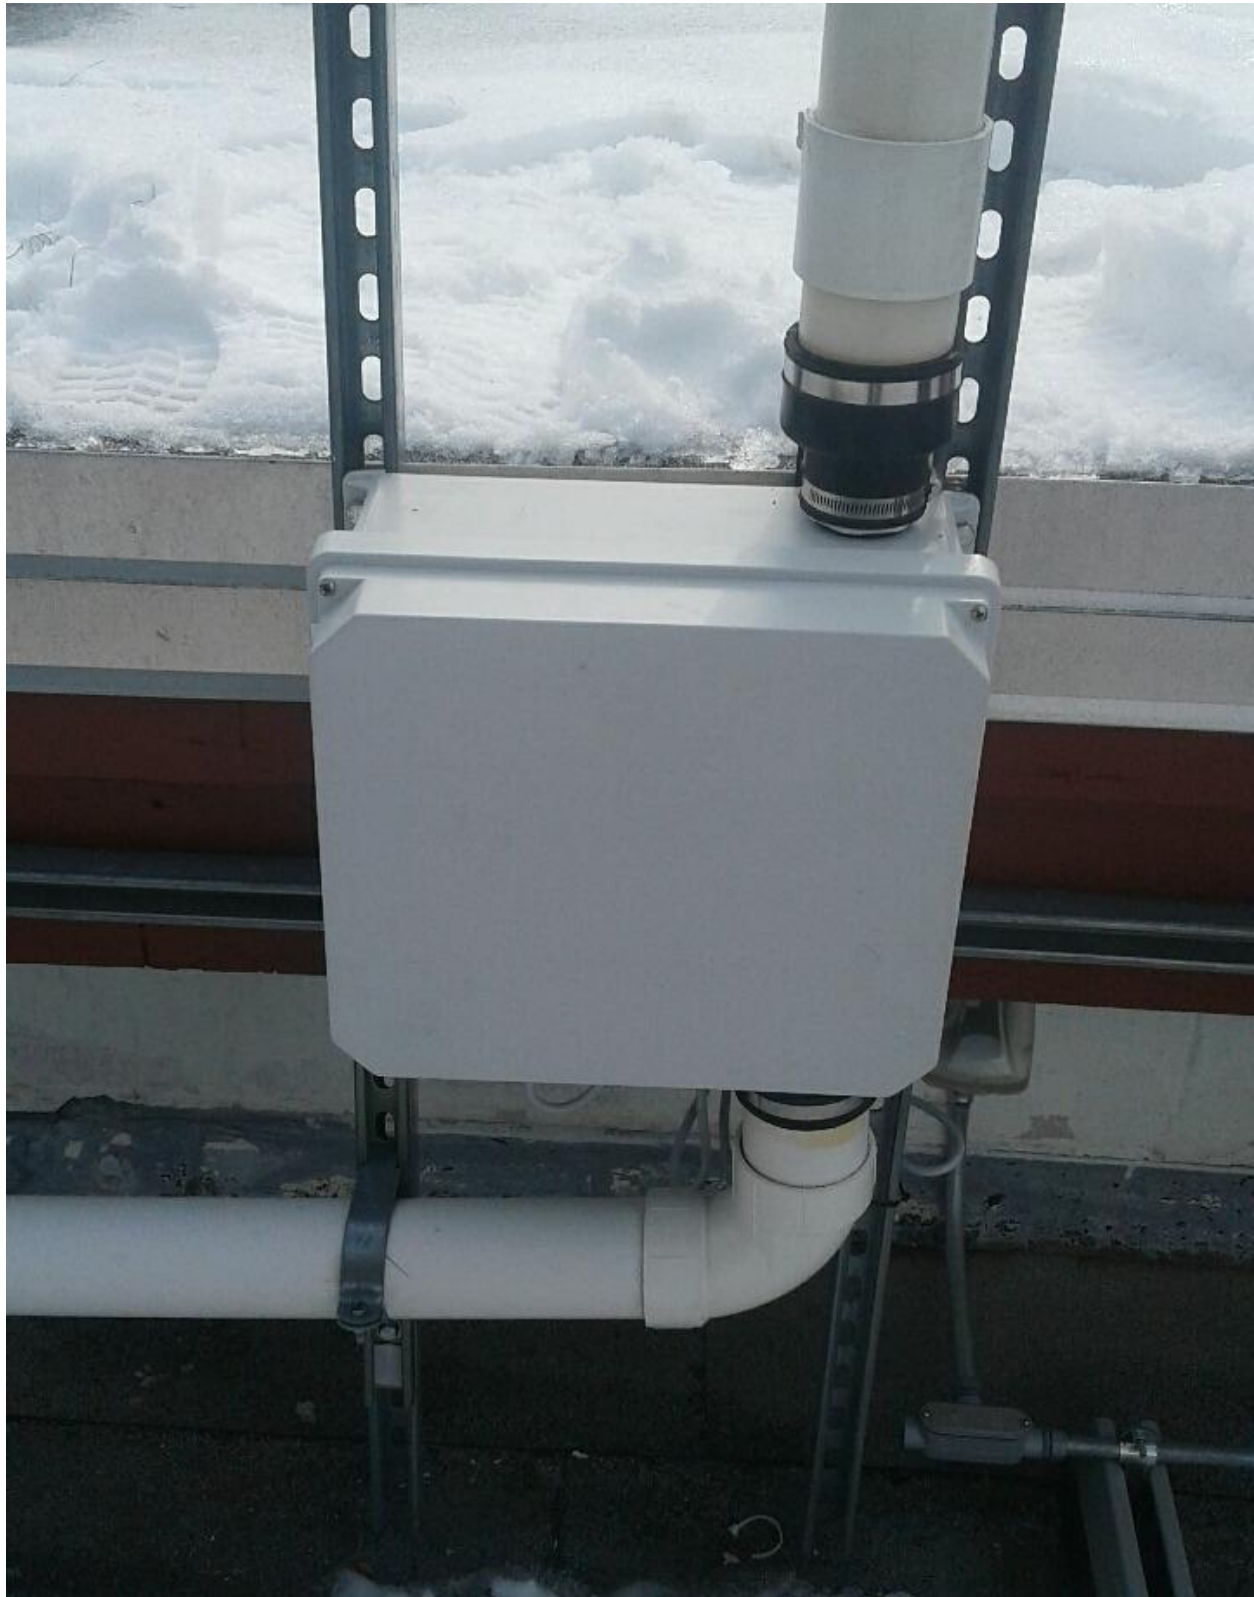
**Seen here is the Northern Fan after repairs were completed.**

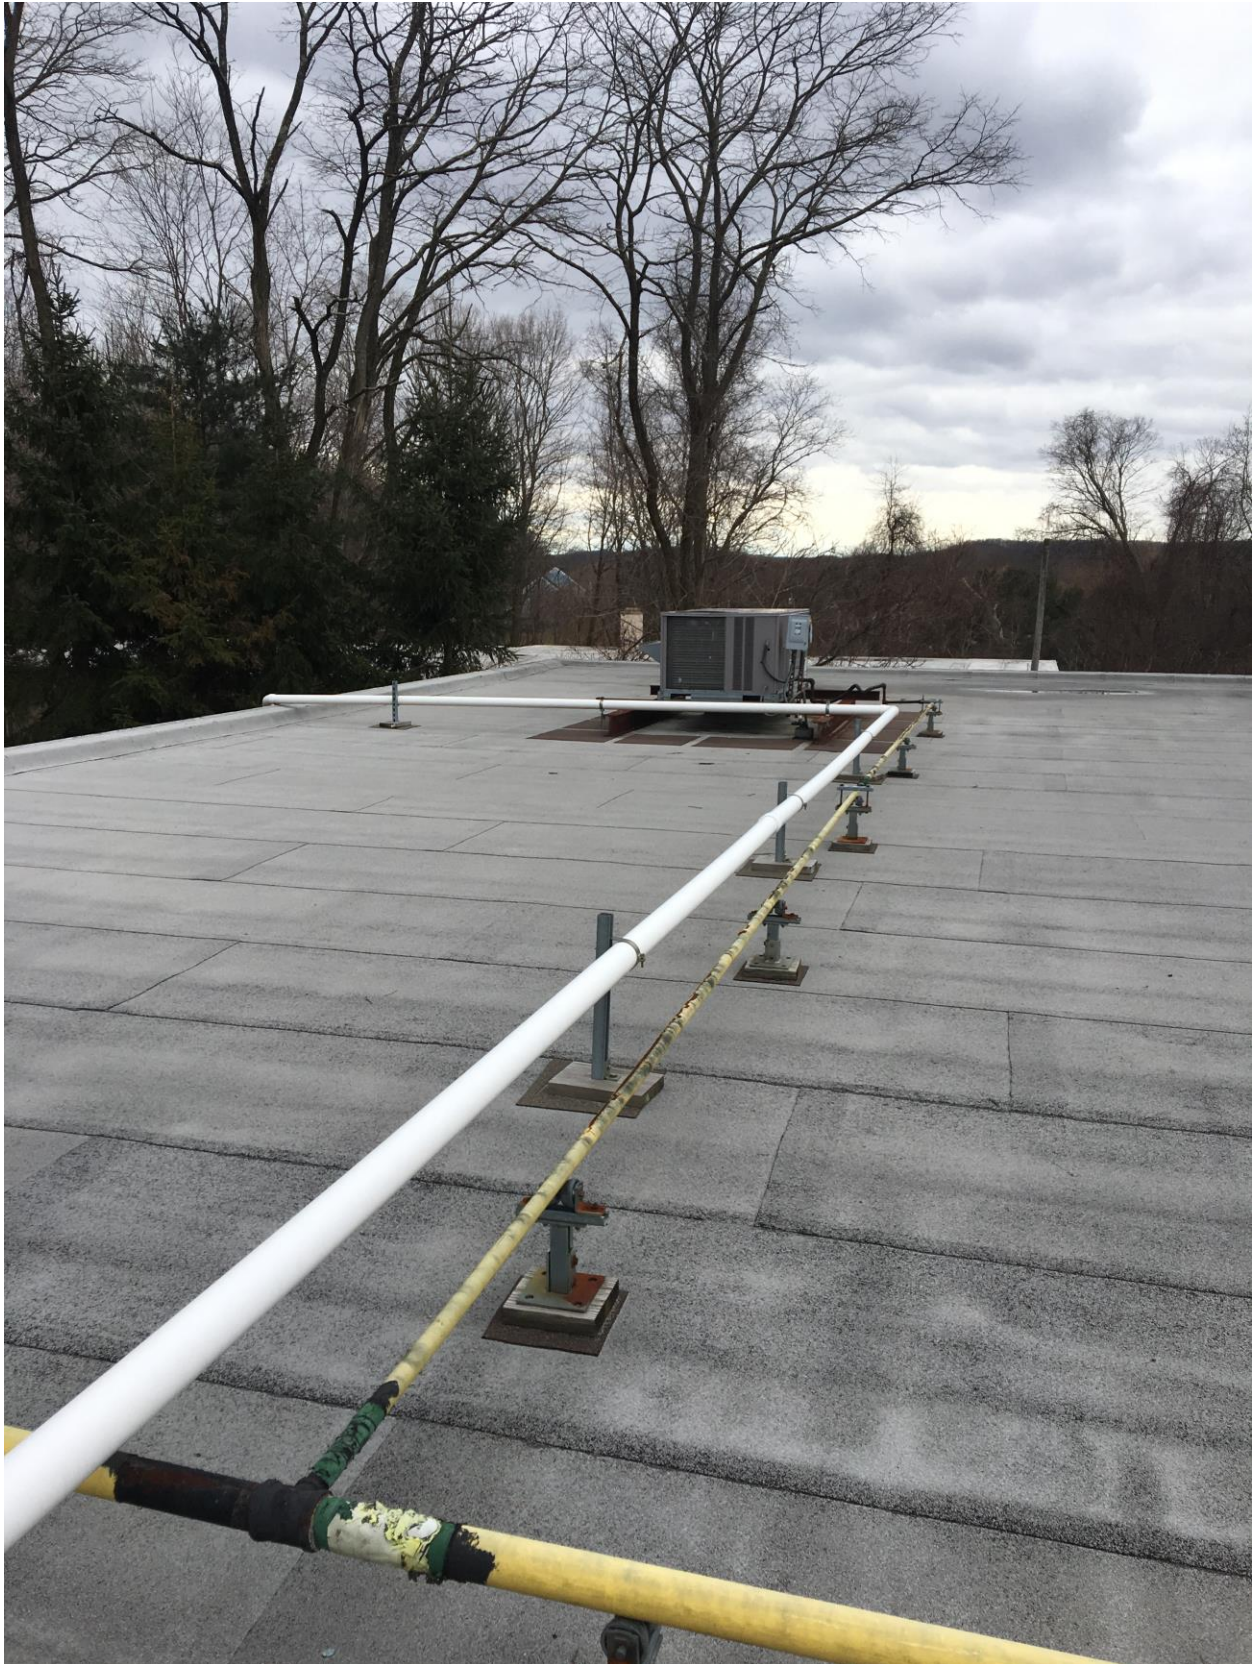
**Seen here is the southern leg of the SSDS. The leg was inspected for proper pitch back to the points for condensation to flow back beneath the slab.**
